Field Report for Airborne Data Collected In Support of US EPA Region 6 South 4 Group Fire 02 December 2019

The US EPA Region 6 requested that the ASPECT system be deployed to provide monitoring support beginning on 27 November 2019. This report summarizes findings observed during the two missions flown on 02 December 2019.

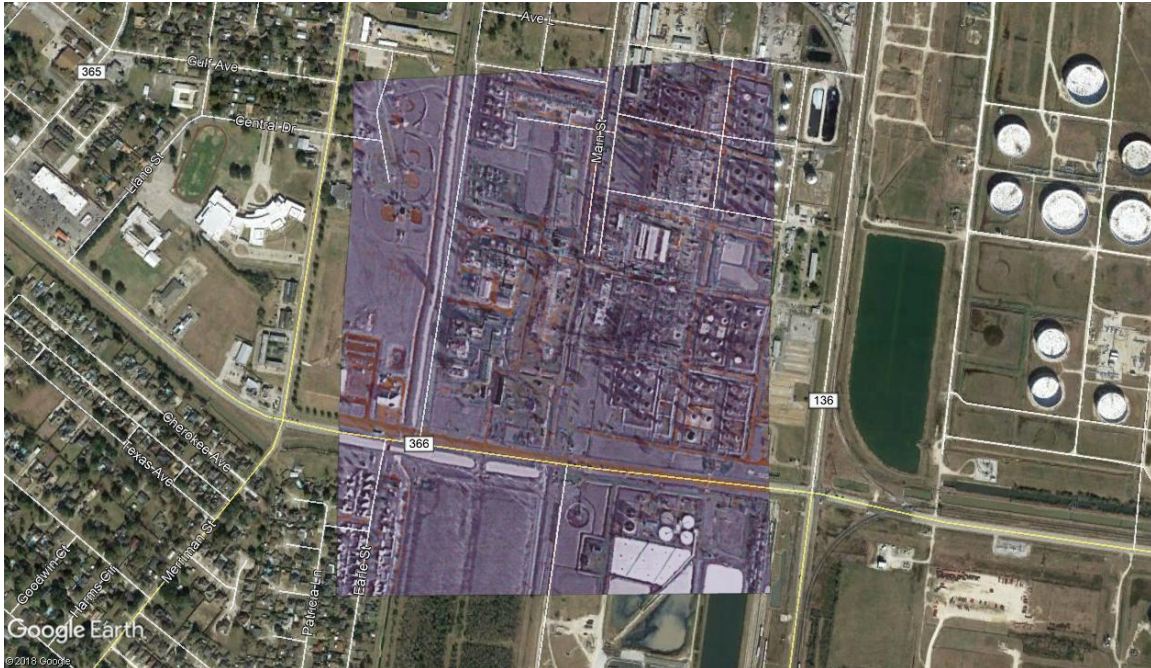
A total of 2 test and 8 data collection passes were made in the proximity of the fire and an infrared line scanner image was generated for each pass. Figure 3 shows a typical 3-band infrared image obtained from data collected for Run 8. The thermal environment of the unit tends to be low. At the time of the IR collection, no water cannon or emissions can be seen in the image. Figure 4 shows a close-up thermal analysis of the production facility again showing very little elevated temperature other what appears to be one hot spot on the northern side of the process unit.

Figure 3: – 3 band IR image, Flight 10, Run 8, South 4 Group Fire

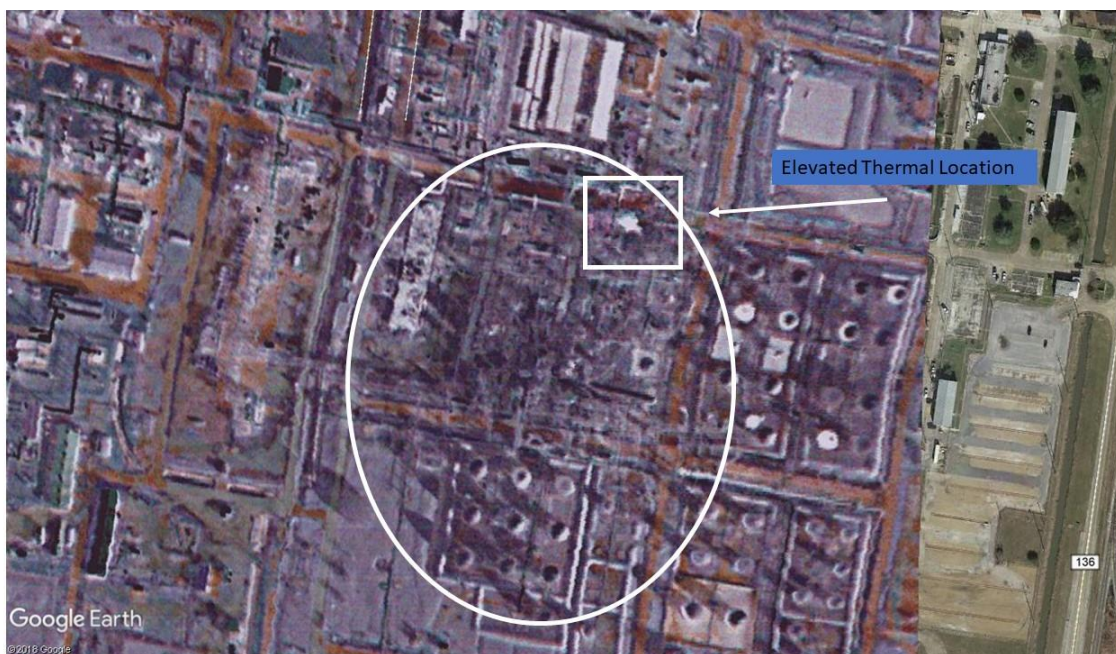
Figure 4: -- 3 band IR Image, Flight 10, Run 8, South 4 Group Thermal Image

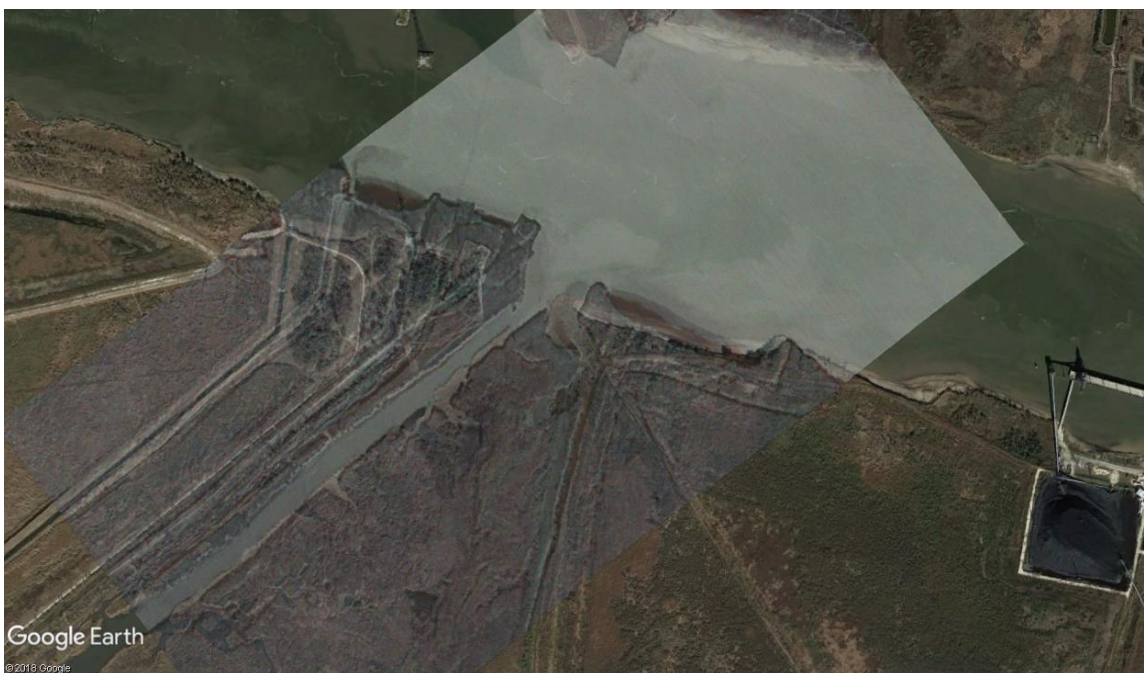
To check for possible oil migration from the site, ASPECT was flown along a waterway leading from the east side of the facility to the Naches River. Figure 5 show an IR image of the waterway flowing into the River. No sheen can be seen in the image.

Figure 5: -- 3 band IR Image, Flight 10, Run 10, Waterway Image, South 4 Group Fire

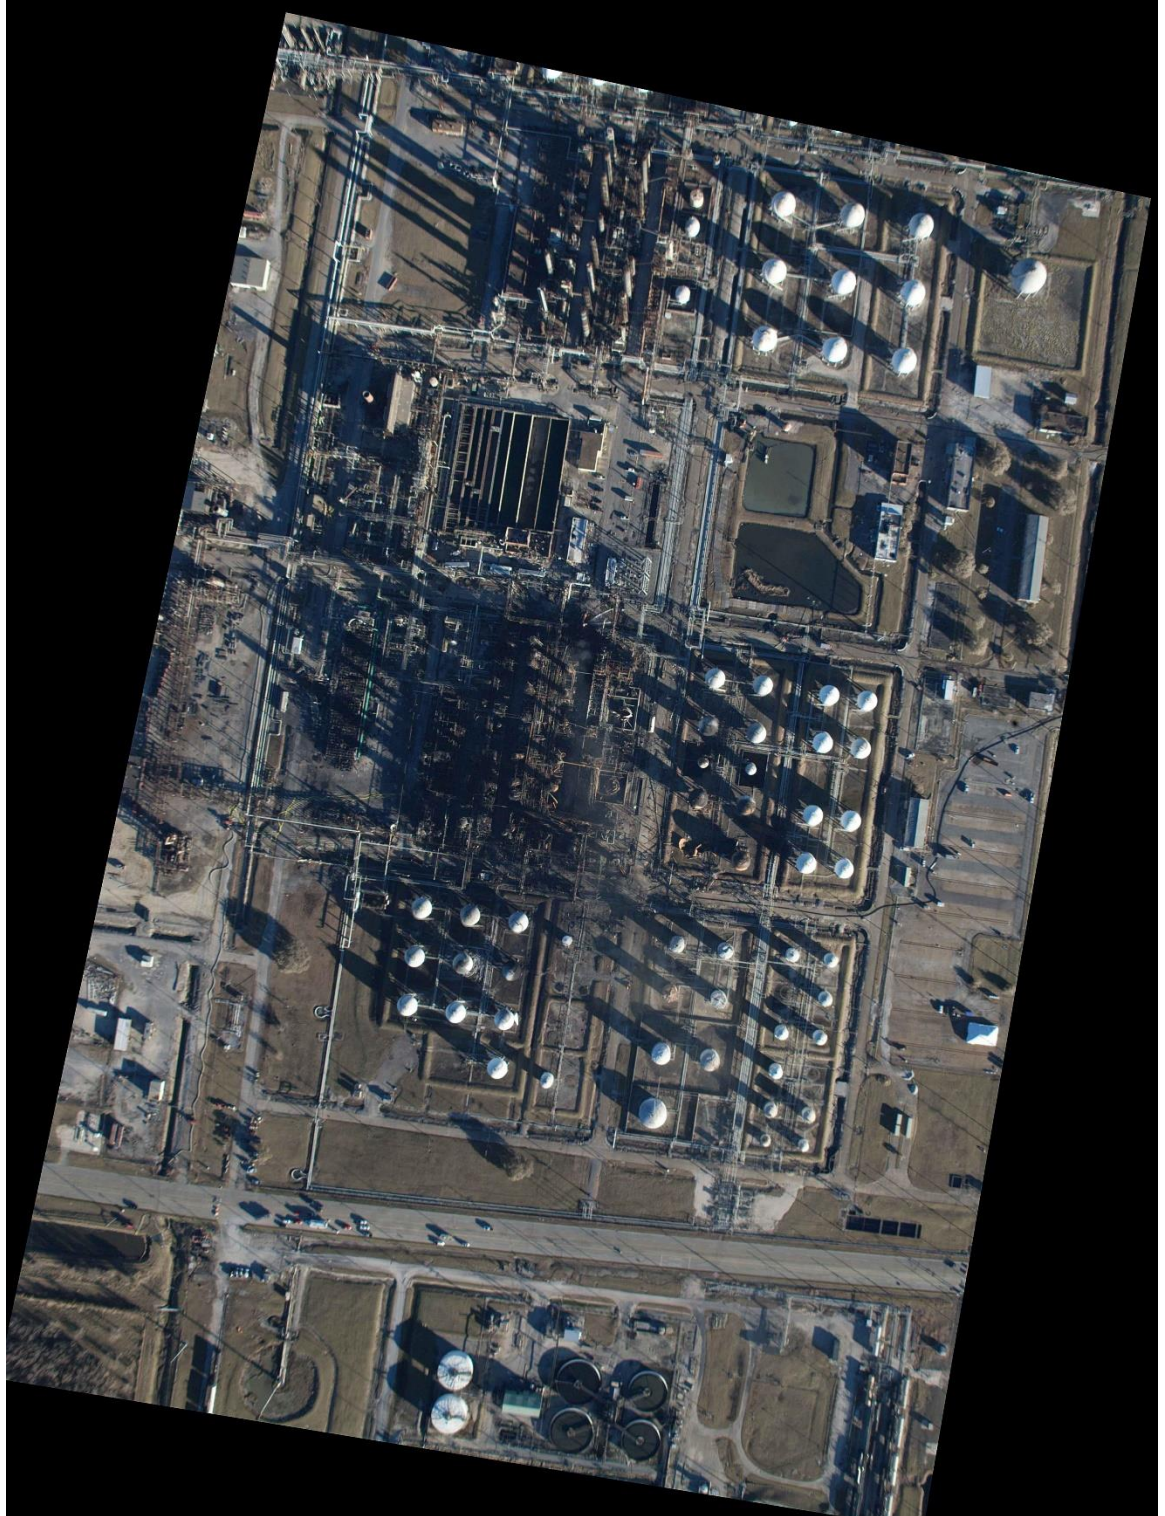
A full set of high resolution aerial digital photography were collected as part of the flight. Figure 6 shows a representative image collected as part of each pass. Consistent with the crew report, a small amount of smoke was observed being emitted from the site. The oblique image in Figure 7 shows the presence of one fire on the north side of the unit. At the time of the oblique collection, one water cannon was in operation.

Figure 6: Aerial Image, Flight 10, Run 6, South 4 Group Fire.

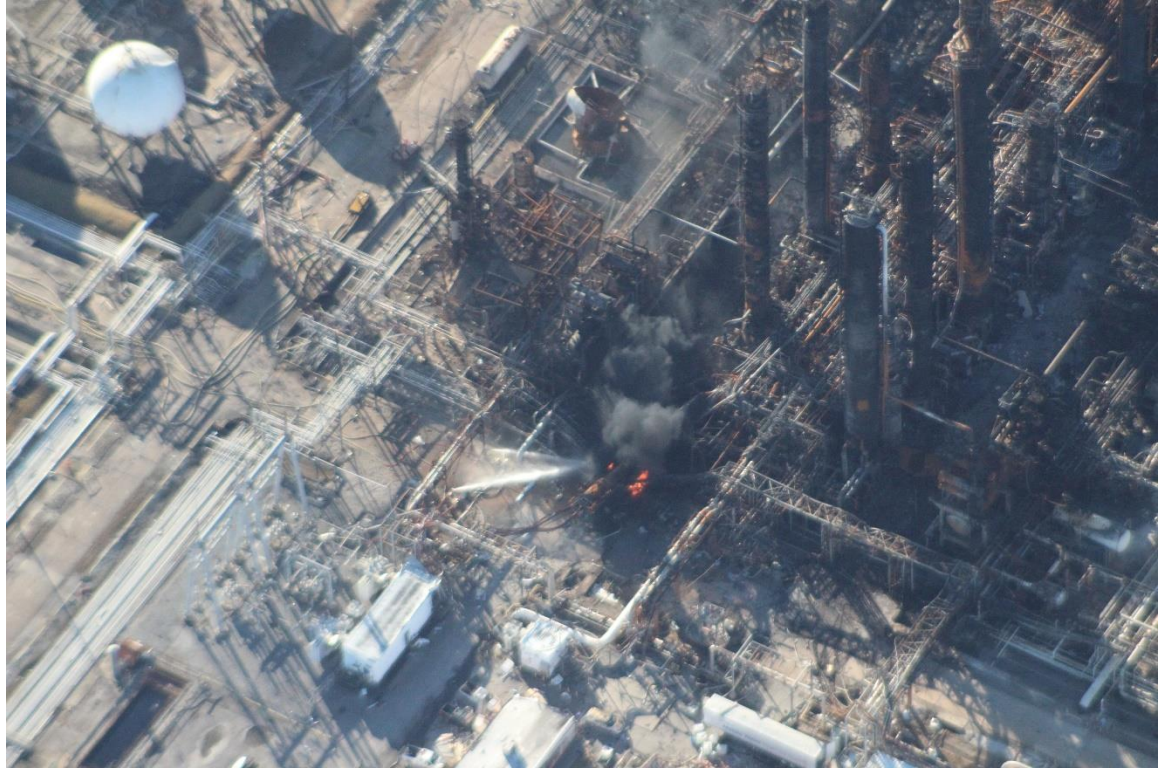
Figure 7: Oblique Image of the South 4 Group Fire

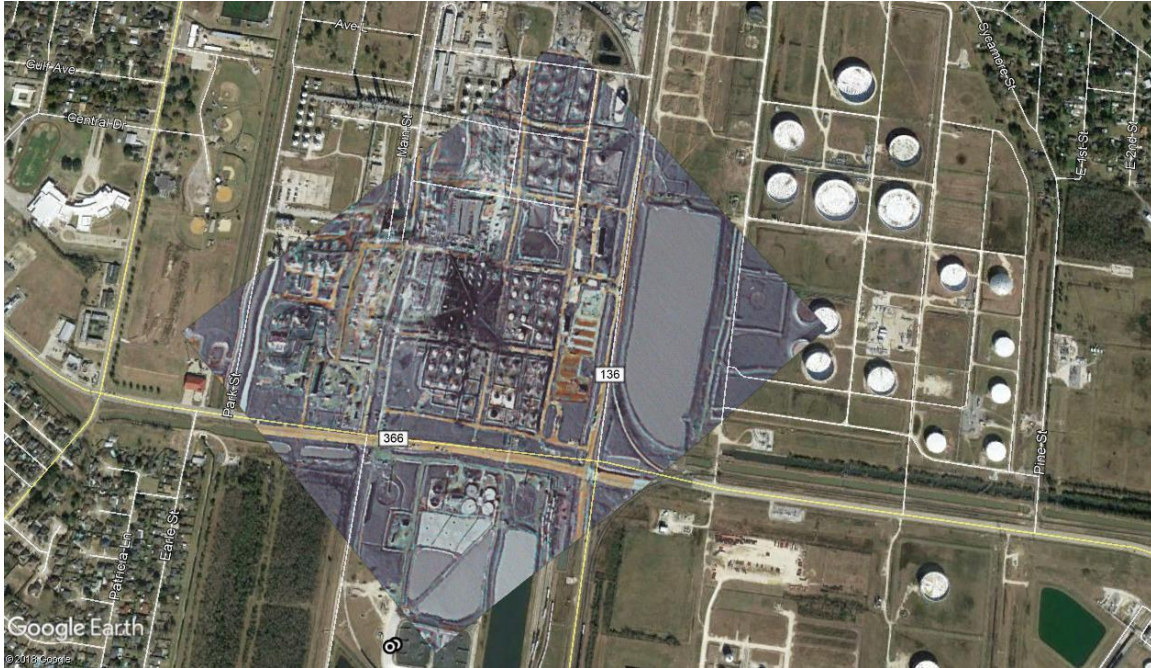
A total of 2 test and 8 data collection passes were made in the proximity of the fire and an infrared line scanner image was generated for each pass. Figure 9 shows a typical 3-band infrared image obtained from data collected for Run 2. Examination of the frame shows that four water cannons are being used to cool the central part of the unit. No chemical plume can be observed being emitted from the facility. A close-up image taken from pass 7 is given in figure 10. The reactor towers tend to show temperature higher than the surround area with a defined high temperature location on the northern part the process unit. Figure 11 shows the waterway entry into the Naches River. Analysis of the image does not show a sheen but there does appear to be water flowing into the river.

Figure 9: -- 3 band IR image, Flight 11, Run 2, South 4 Group Fire

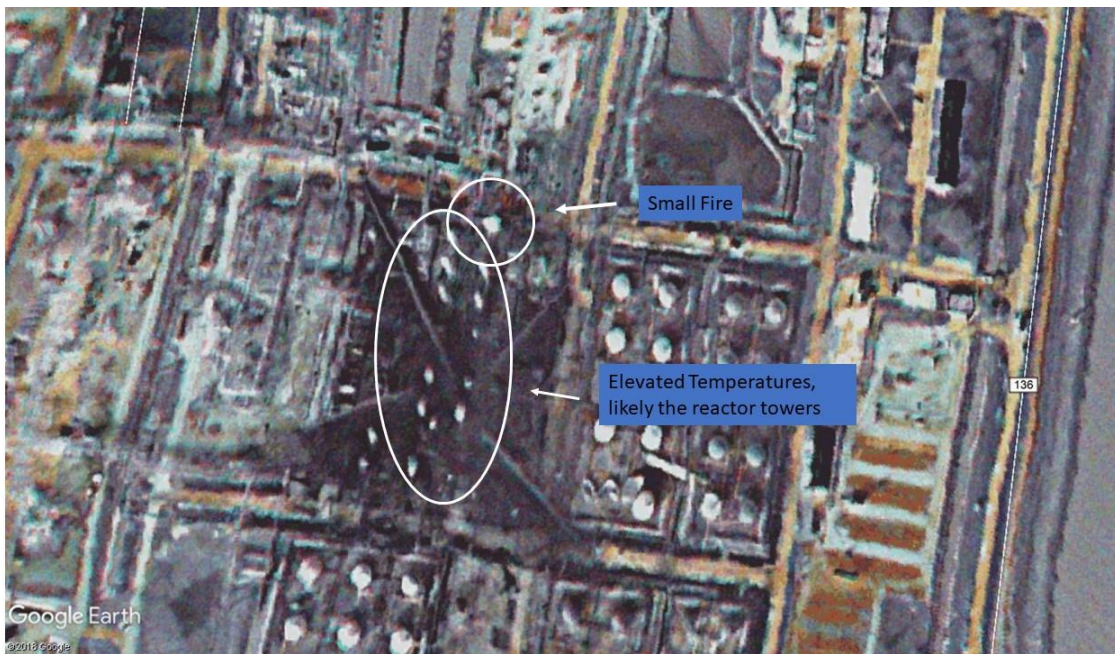
Figure 10: -- 3 band IR image, Flight 11, Run 7, South 4 Group Fire

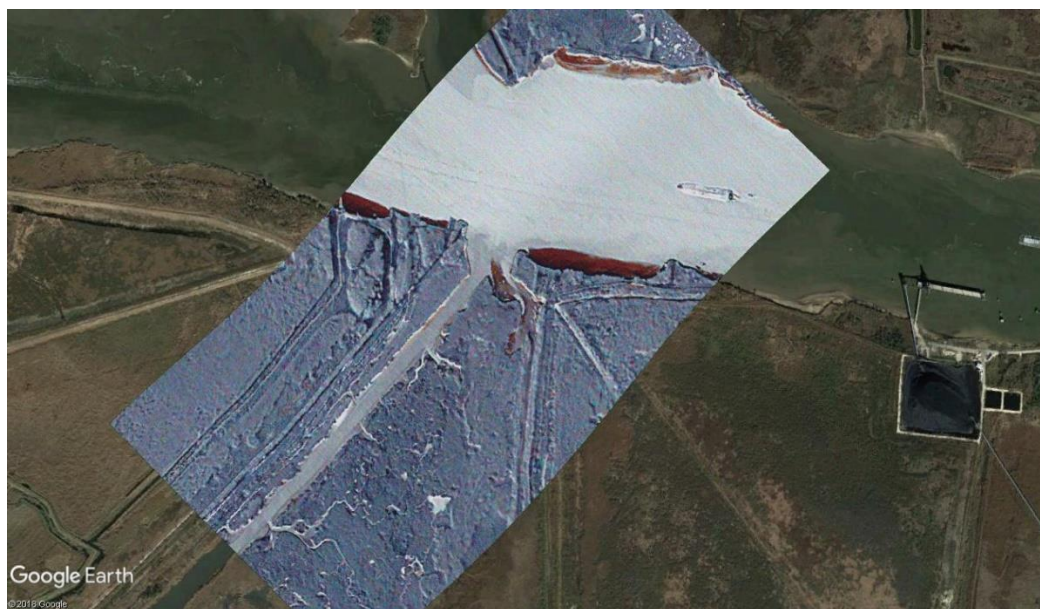
Figure 11: -- 3 band IR image, Flight 11, Run 10, Waterway, South 4 Group Fire

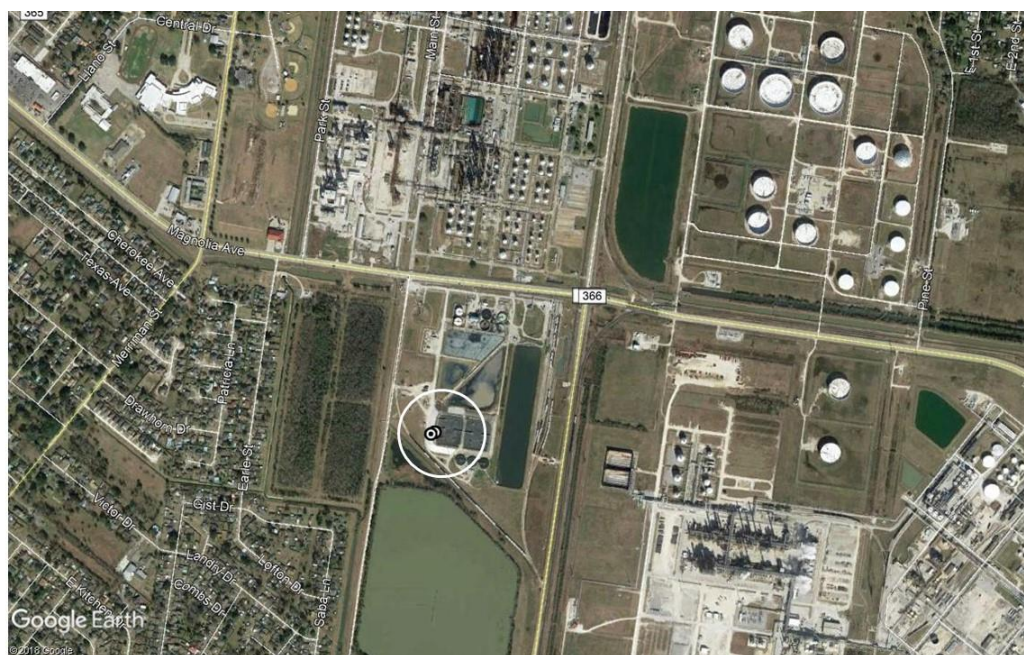
Signatures corresponding to isobutylene were detected due south of the facility near the wastewater treatment plant. Figure 12 shows the location of the detection cluster which had a maximum concentration of 1.57 ppm, just slightly above the detection limit of the system. A summary of data of the data collection is given in table 6.

Figure 12: -- Isobutylene Detection Locations, Flight 11, South 4 Group Fire

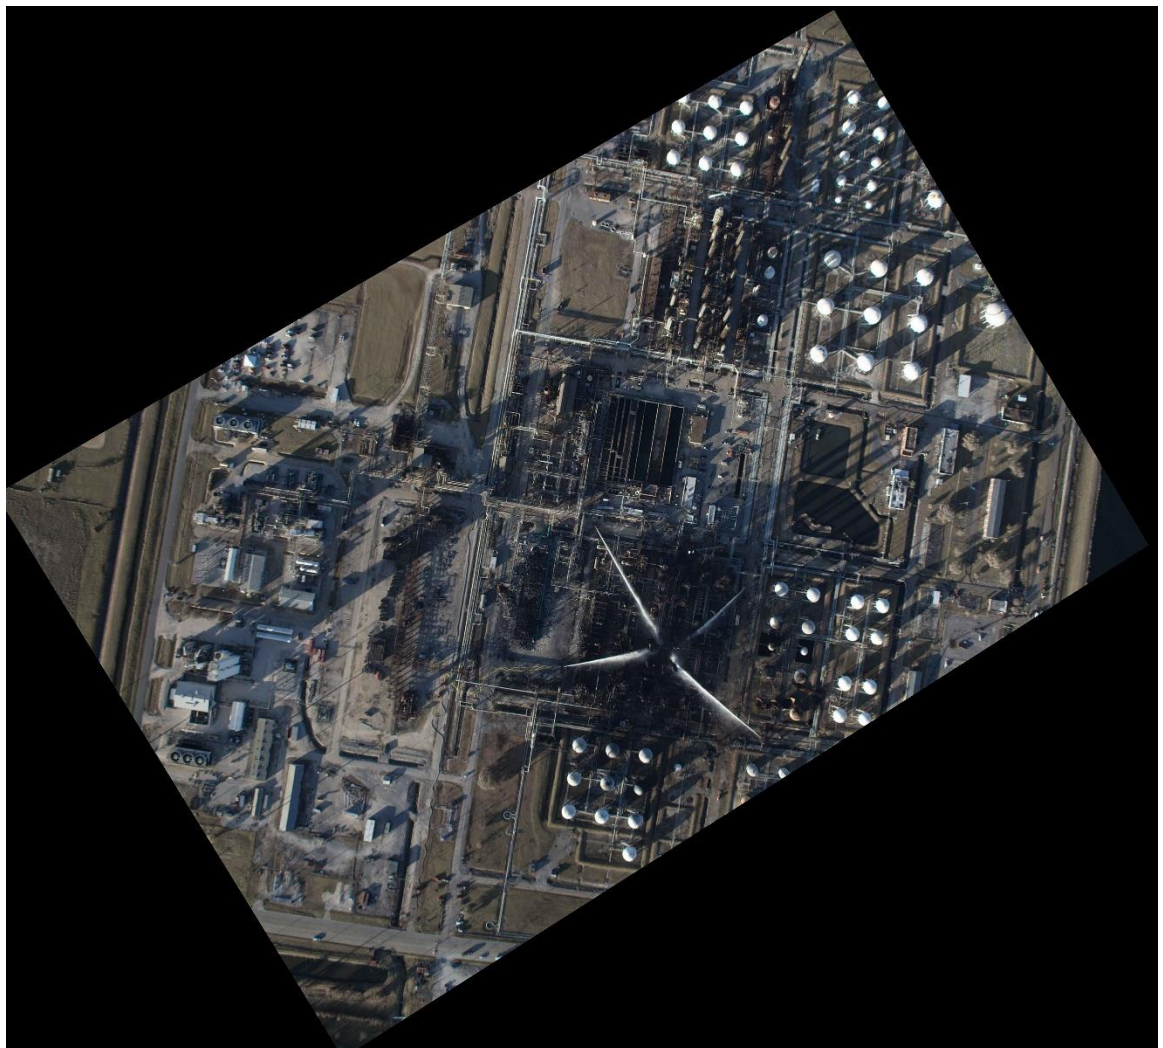
A full set of high resolution aerial digital photography were collected as part of the flight. Figure 13 shows a representative image collected as part of each pass. As reported by the flight crew, very light smoke is being generated by the fire. At the time of collection,

Figure 13: Aerial Image of the South 4Group Fire, Flight 11

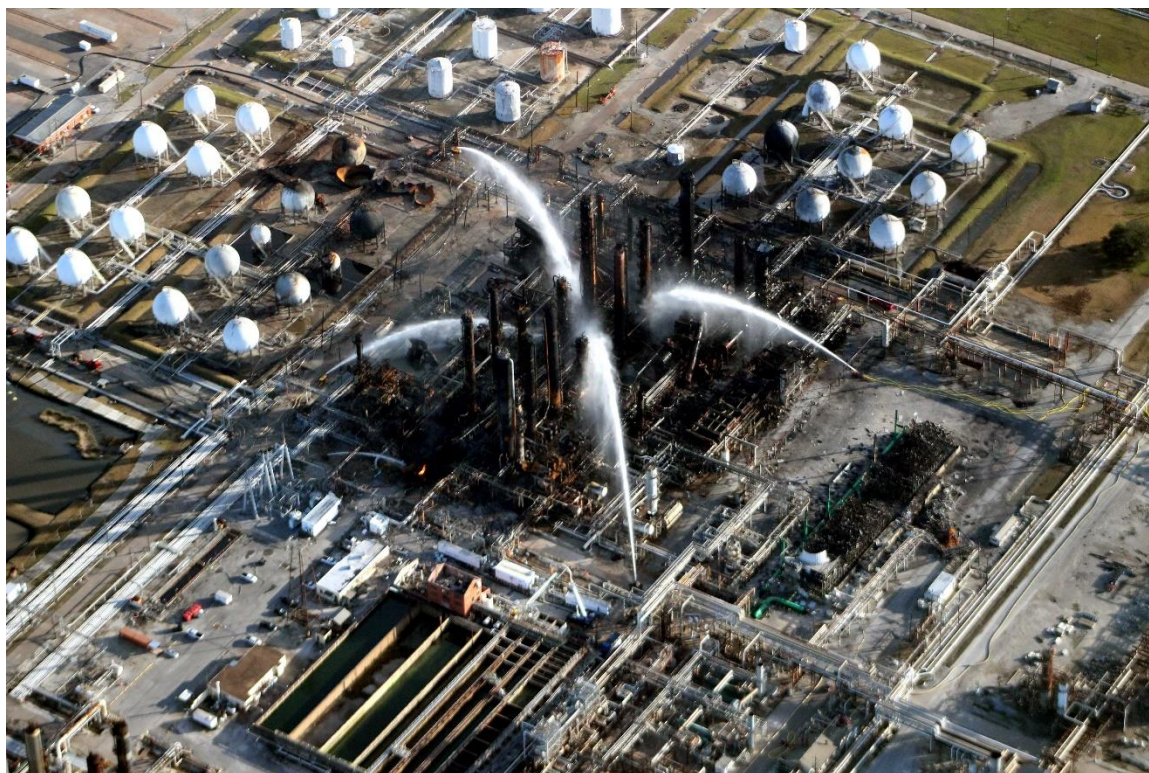
four large water cannons were dumping water into the middle of the process unit (figure 14). A smaller cannon was directing water on the fire located on the northern edge of the unit.

Figure 14: Oblique Image of the South 4Group Fire, Flight 11
